MORRISON

HOME INSPECTIONS, INC.

INSPECTION REPORT
100 Foothill Dr., Anaheim, Ca 92805

Inspection Date: 9/10/2010
Report Number: 2010100100
Real Estate Agent: N/A
Home Inspector: Duane Morrison

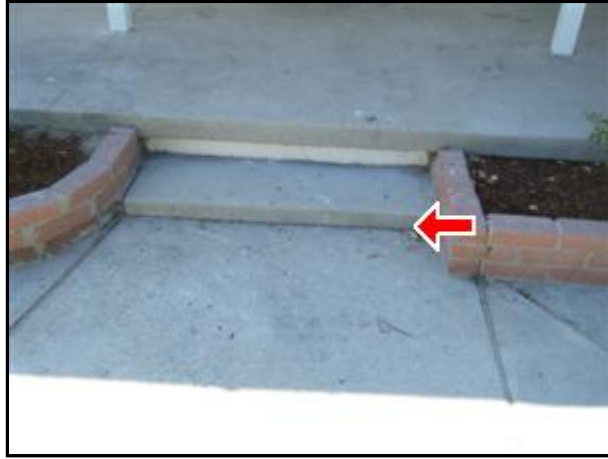
2.2 Picture 1

Steps are not the same height at the right side and rear. Recommend correcting.

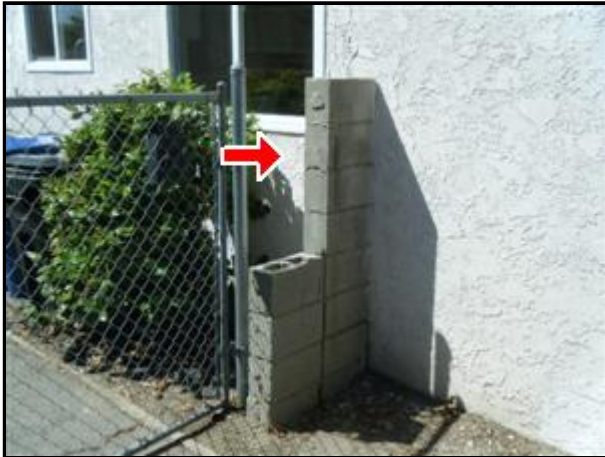
2.3 Picture 1

- (1) Limited review due to vegetation, covering or personal items.
- (2) Charred wood fencing observed at rear. Suggest maintenance.
- (3) Loose blocks observed at right side and exposed rebar observed at left side. Recommend correcting.

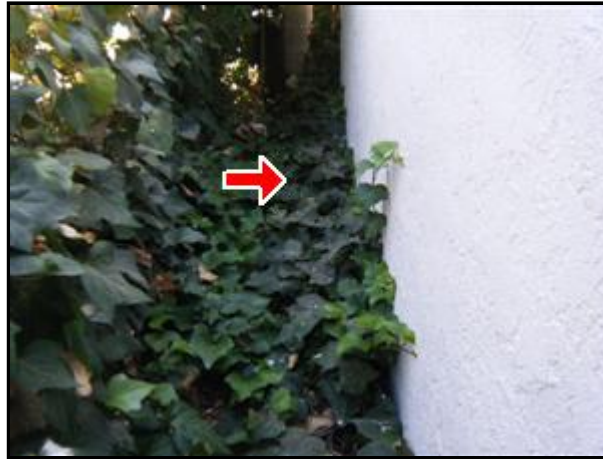
2.4 Picture 1

(2) Siding is in contact with vegetation at garage. Recommend removal.

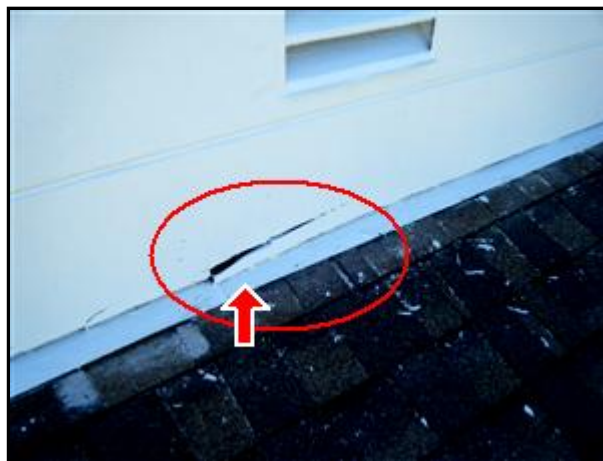
2.4 Picture 2

(3) Loose wood wall covering at left side gable. Suggest correcting.

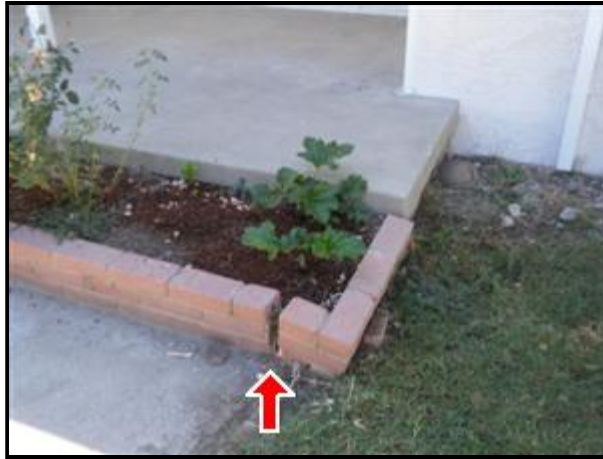
2.10 Picture 1

- (1) Insufficient clearance observed between planter and house. A two inch space between the planter and exterior wall is recommended to prevent moisture penetration. Recommend correcting.
- (2) Cracked brick observed at planter. Suggest repair.

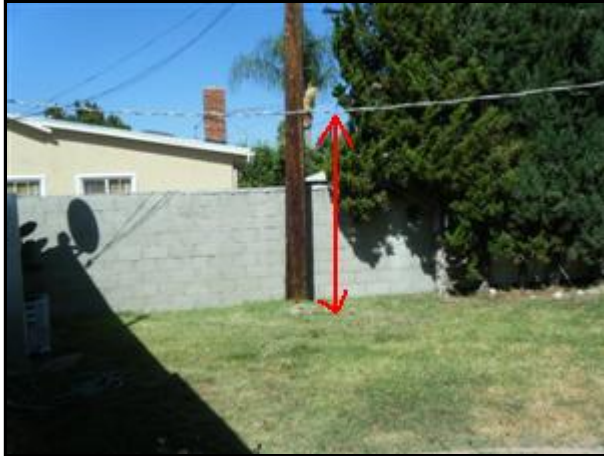
4.0 Picture 1

Main service wires are overgrown with vegetation and less than 10 feet above the rear walkway. Recommend contacting the local utility and correcting.

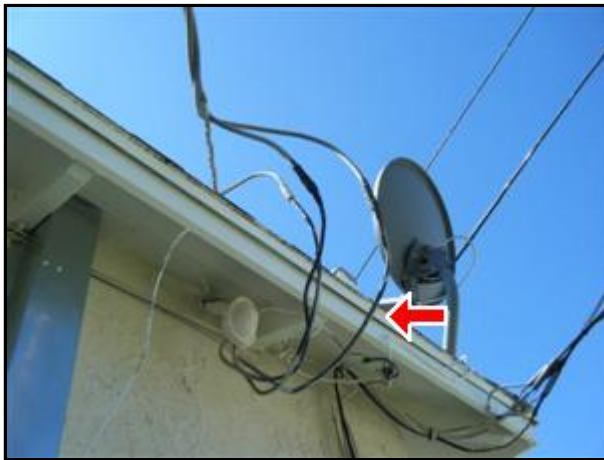
4.1 Picture 1

Mast is installed below the roof deck and wiring is wrapped around the eave. Recommend correcting.

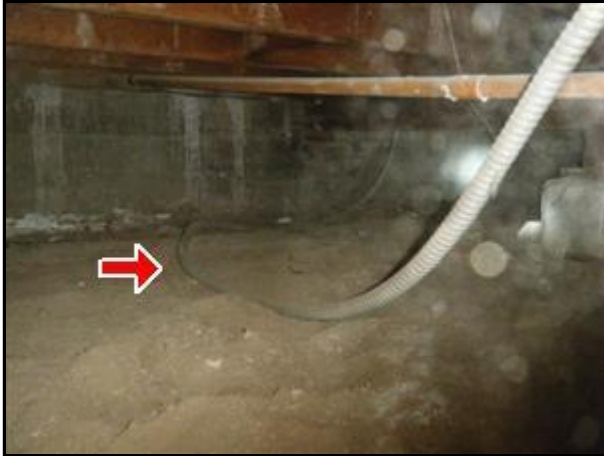
4.5 Picture 1

Conduit lying on the ground (Picture 1) and open junction box (Picture 2) observed in the crawlspace. Recommend correcting.

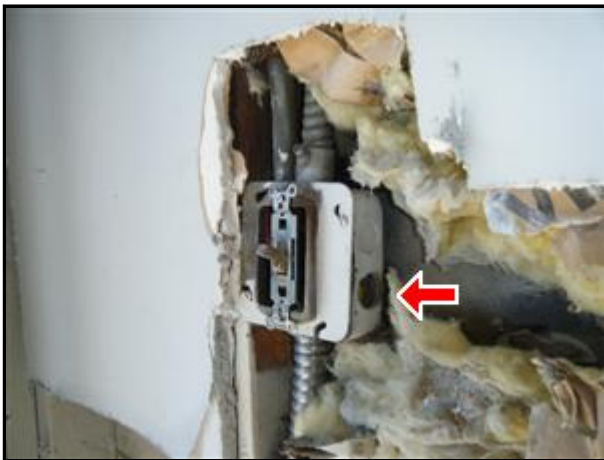
4.7 Picture 1

(1) Cover plate is not installed at exterior outlet located at the front porch - same three pronged outlet is ungrounded. Recommend correcting.

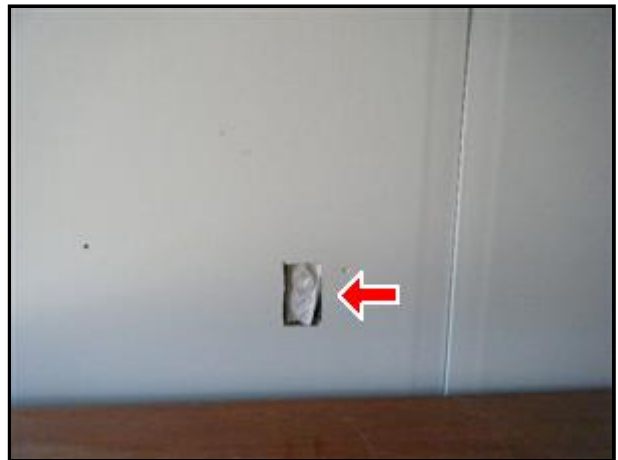
4.7 Picture 2

(2) Cover plates are missing at garage and open junction box observed. Recommend correcting.

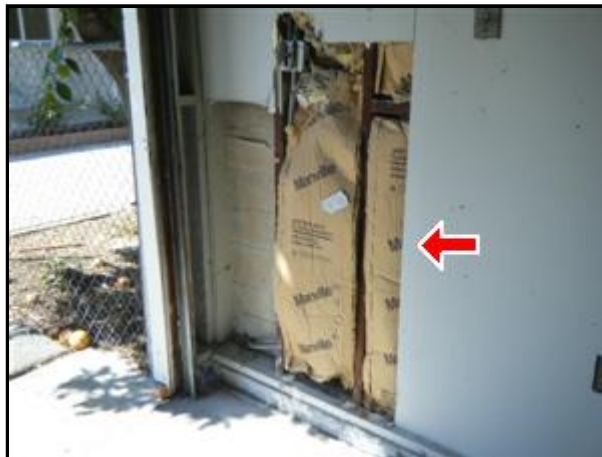
5.2 Picture 1

(1) Cut-out areas observed. Suggest correcting.

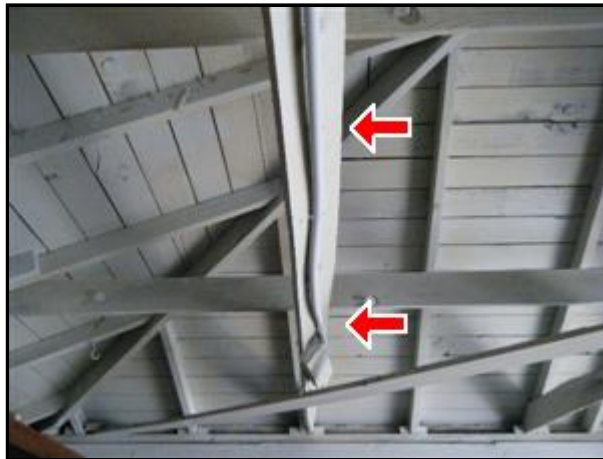
5.2 Picture 2

(2) Collar ties are deflecting and improper installed. Recommend replacing.

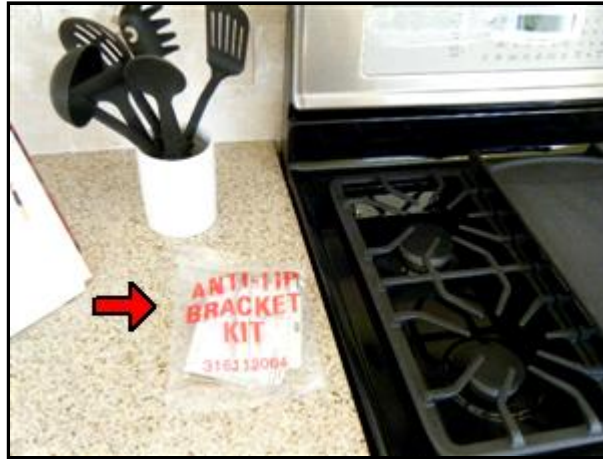
7.7 Picture 1

Anti-tip bracket is not installed. Recommend installing.

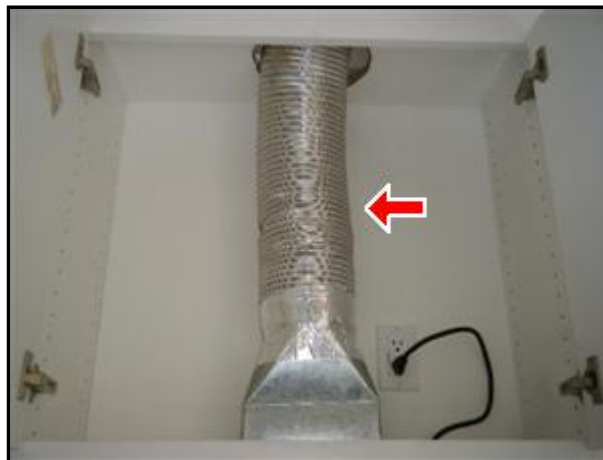
7.8 Picture 1

Improper flexible material used for the exhaust vent. Recommend correcting.

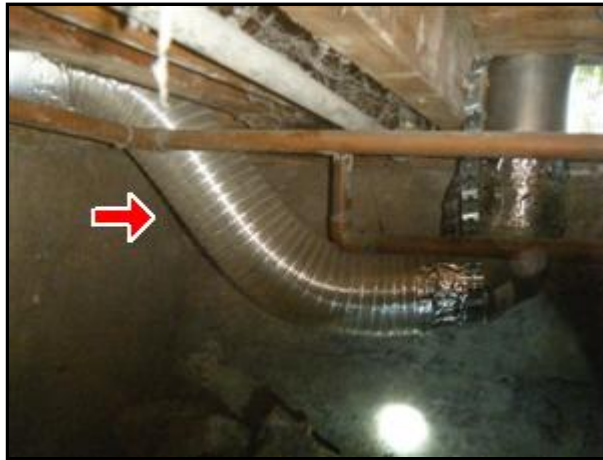
8.1 Picture 1

(2) Improper installation of flexible vent in the crawlspace. Recommend correcting.

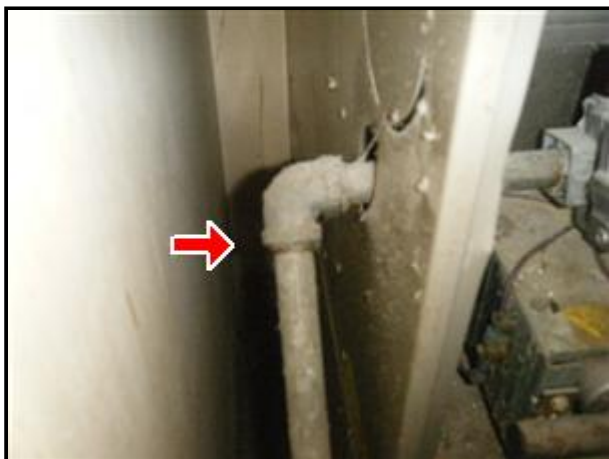
11.1 Picture 1

(1) Inadequate combustion air supply observed. Recommend correcting.

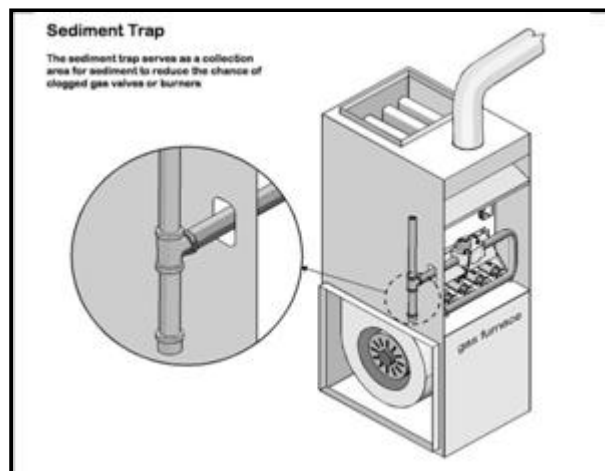
11.1 Picture 2

(2) Sediment trap is not installed at the gas line. Recommend installing.

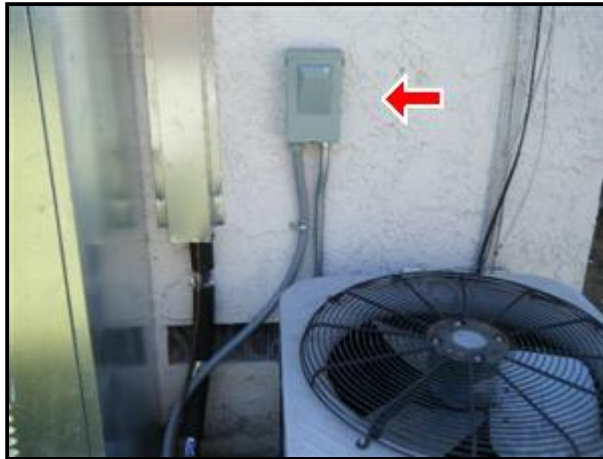
11.2 Picture 1

(1) Main disconnect installed is improperly installed behind the compressor. Recommend correcting.

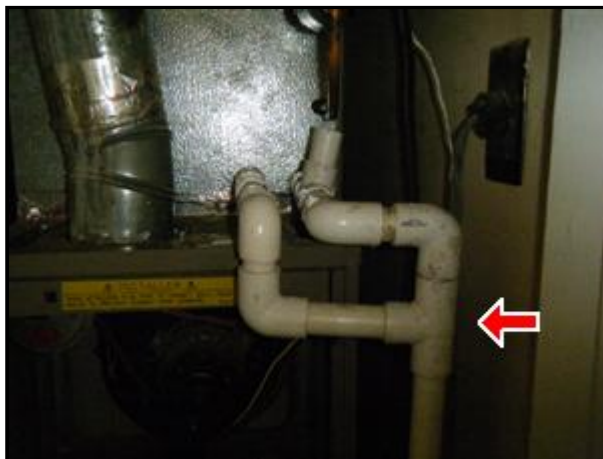
11.2 Picture 2

(2) Primary and alternate condensate drain lines are connected. Recommend separating into independent drain lines.

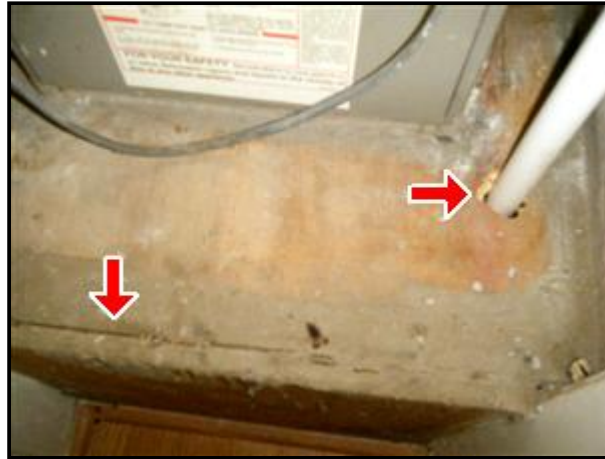
11.5 Picture 1

Gaps observed at the return air plenum. Recommend sealing.

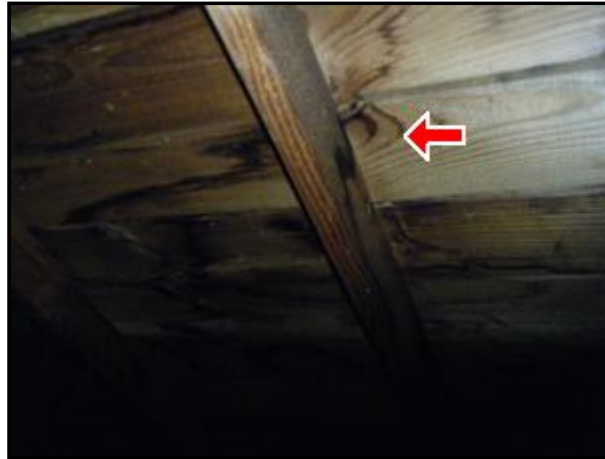
12.3 Picture 1

Water stains observed at sheathing. Recommend further review by a licensed roofer, prior to the close of escrow.

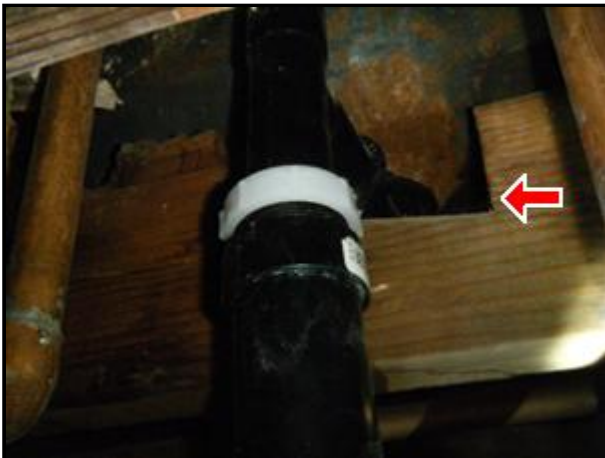
13.2 Picture 1

Improper notching observed at left side and front/right. Recommend correcting.
